# INVESTIGATING THE POTENTIAL IMPACTS OF THE ARABIAN MINE ON WIDENING OF SR 68, MOHAVE COUNTY, ARIZONA

Robert Cummings, P.E., Saguaro GeoServices, Inc.<sup>1</sup>

Nick Priznar, Arizona Department of Transportation<sup>2</sup>

Interstate Technical Group on Abandoned Underground Mines, Tucson AZ , April, 2004

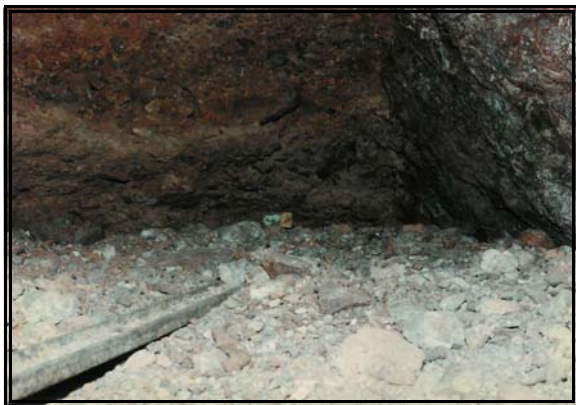
Underground, the workings run chiefly along the strike. Crosscutting is indicated on old maps to have reached the footwall contact with the granite and the hanging wall contact with the gravel (Figure 7). This means that there is an efficient subsurface hydraulic connection between ground water and the workings. In fact, the workings are flooded below the 100 level and water has been extracted – in small quantities – in the past. Because of the flooding, none of the mine levels below the "100 level" could be accessed without extensive pumping of the mine. Water levels now are very similar to those reported in the records from as long ago as the 1930s.

**Figure 7 – Crosscut ending in gravel off the Philadelphia No. 1 shaft**

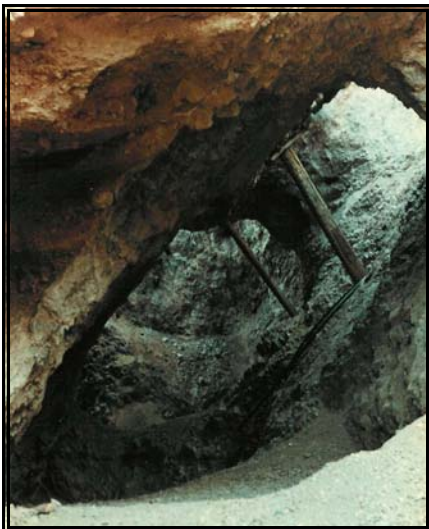
By the time the mine came under consideration for roadway widening, the Arabian Mine had not been worked for some time. Some open workings were evident at the surface (Figure 10). Some workings consisted of shallow holes connecting former stopes (Figure 11, note small diameter polyethylene pipe used to extract water).

**Figure 11 – Stopes used for water extraction**

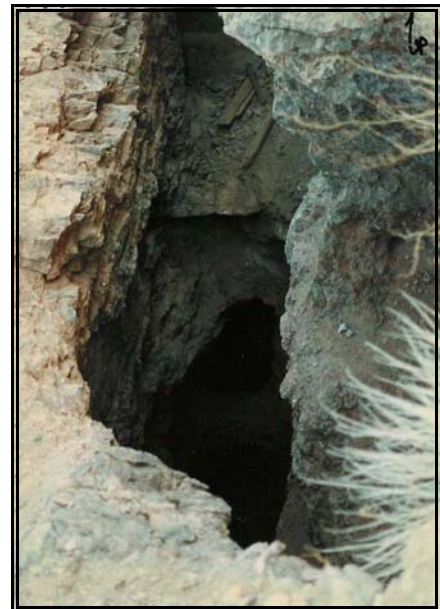
**Figure 10 – Stopes open at surface**

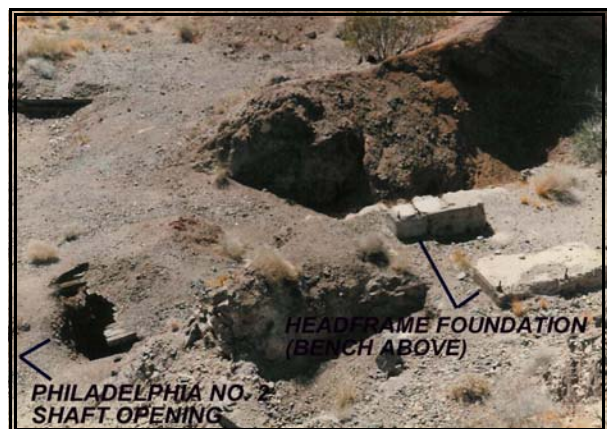
**Figure 18 – Philadelphia No. 2 shaft in 1991**

Comparison of the old records with present conditions reveals that the Philadelphia No. 2 Shaft no longer collars at the same elevation it originally did. Shaft timbers once extended about 44 ft below the collar; they presently stop a little over 10 ft down, apparently from unrecorded mining of the dump material that once comprised the shaft walls. The remaining timber was found to be mostly loose and hanging, with free-running gravel behind, making mine entry hazardous. The inclination was measured at 48 -50 degrees, slightly steeper in the timbered portion.

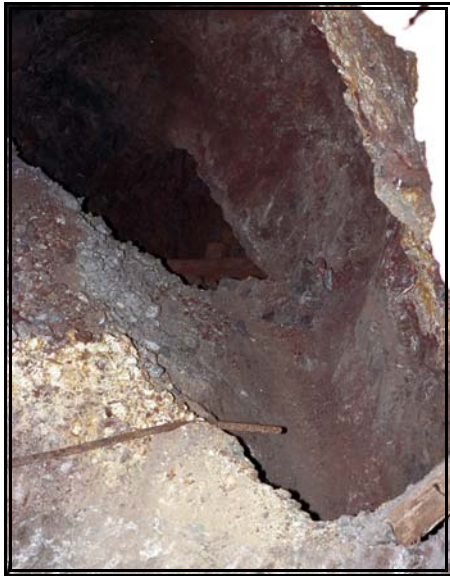
**Figure 19 – 100 Level stope off the Philadelphia No. 2 shaft**

relative to the location of the roadway corridor. The assessment of the integrity of the mine workings and the likelihood and character of potential threats to the roadway due to the presence of the workings underneath it (particularly the stopes), could not, because of the flooding, be observed directly. Underground observations did show that the stopes cannot be accurately described as regular, tabular voids that have consistent orientations (Figure 19).

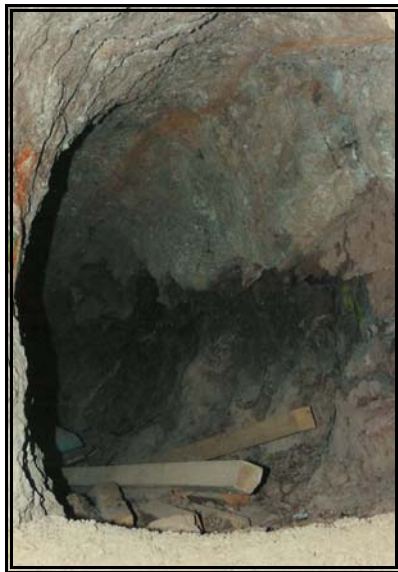
though silicified and intensely fractured or crushed without much clay, is fairly soft. One fault contains as much as 1 ft of slickensided, clayey gouge, and has spalled moderately (Figure 21). The stability of the workings is probably attributable mostly to the absence of rock stress, owing to the shallow depth.

**Figure 21 – Rib spalling in fault zone, 60- Level drift off the Philadelphia No. 1 shaft**

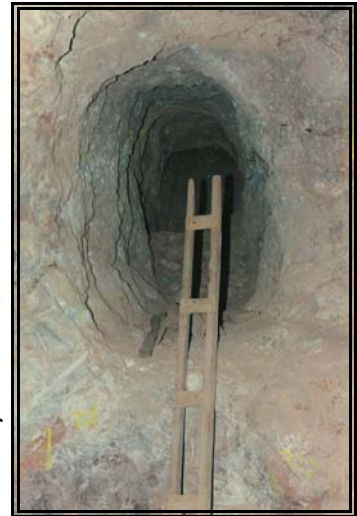
The Philadelphia No. 1 Shaft is inclined downward at an angle of 57 degrees. It opens at the bottom into a chamber (Figure 20) that probably served as the shaft station and loading station. Rock conditions in the shaft itself are excellent. Branching drifts appear to be the same ones shown on a 1916 survey map, which corresponds quite closely to the results of the EI survey. None of the Philadelphia No. 1 workings appears to persist as far as the roadway. The furthest drift to the east is nearly filled to the back and stops at the contact with the gravel (see Figure 7). The entire level seems to be above the water level at all times, and there are no drips or seeps, although some locations of minor past seepage were noted. The gravel is very dense and compact, and tends to fall in chunks. It may be weakly cemented. The ribs in general are drummy and the rhyolite,

**Figure 20 – Chamber at bottom of Philadelphia No. 1 shaft, with crosscut ahead**

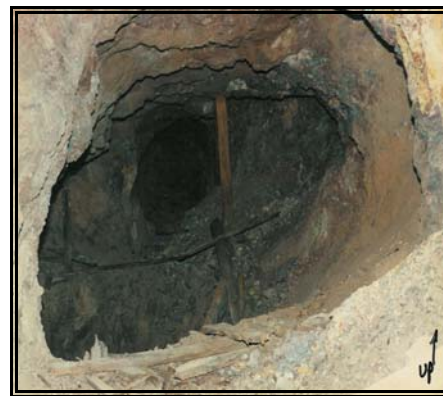
The accessible portions of the "100" level coincide closely with Chock's and other maps. However, it appears that an ore chute was added above the stope on the south side of the No. 2 shaft that is not shown on any maps, and this suggests that a shallower stope and some deeper workings may not be shown on Chock's map. To the north, the "100" level has been partially filled with muck. To the south, the level cannot be accessed from the shaft because to do so would require traversing a loose muck slope at the top of a deep, water filled stope. The drift appears to be open (Figure 22) but it doglegs to the

**Figure 22 – 100 Level drift south from Philadelphia No. 2 shaft**

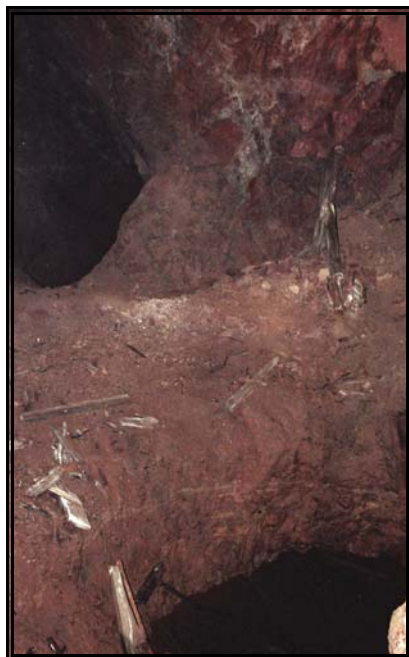
Accessible stopes were generally open, despite prevalent raveling and drummy ribs. No large slabs or extensive cracking was noted. The striking feature of the stopes in terms of assessing their dimensions and stability is the irregularity in dimension perpendicular to the dip. Vertical distances to the stope backs range up to an estimated 40 ft and stope widths range between 10 ft and an estimated 40 ft. Apparently, stopes were widened along ore shoots that may have been elongate perpendicular to the general structural trend. There are no level maps that depict the dimensions of the stopes in this direction, although it appears that the Chock longitudinal section may be a good source of estimated stope lengths along the strike. One report (ca. 1915) describes a "hanging wall ore shoot" at the 200 level as being about 35 ft wide, which may be indicative of stoping widths. Stopes next to the shaft were observed to disappear into the water for as far as could be seen (Figure 23).

**Figure 23 – Water-filled stope off the Philadelphia No. 2**

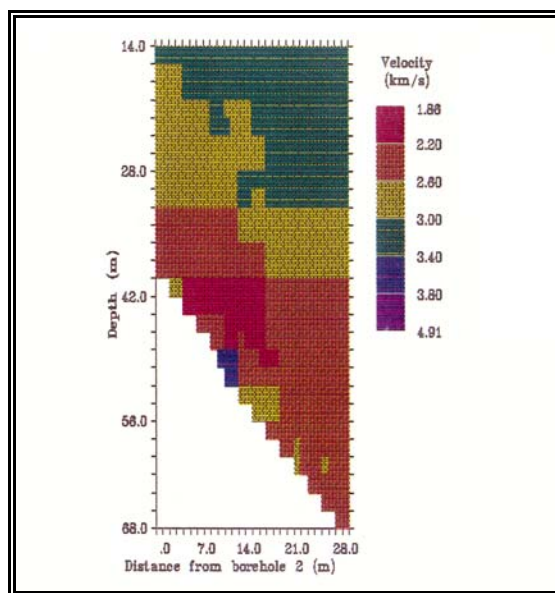
One successful tomographic profile is indicated in Figure 24. The darker red zones are low-velocity areas interpreted as open or water filled voids.

When the tomogram shown in Figure 24 is plotted against the most plausible interpretation of the extent of stopes between the 100 and 200 levels, together with the geologic interpretation drawn from available boring logs and geologic cross sections, a close agreement is obtained.

**Figure 24 – Tomographic profile between boreholes 2 and 5**

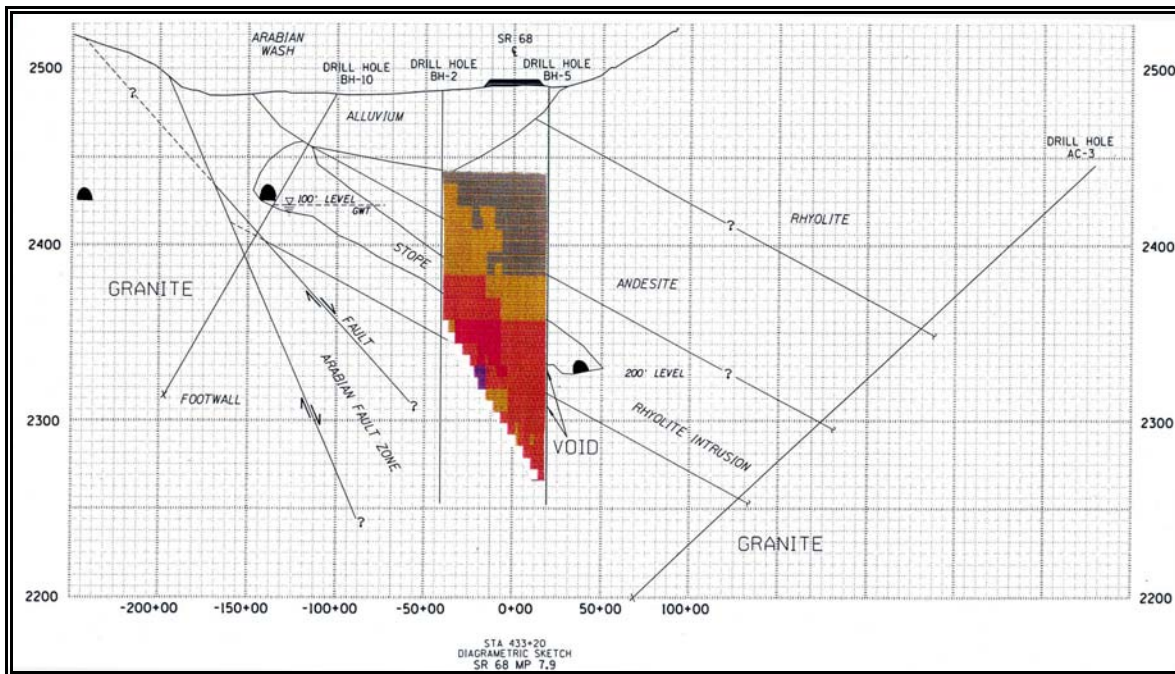
**Figure 25 – Geologic interpretation of tomography between borings 2 and 5**

Figure 25 shows regions corresponding to the gravel fill in the wash bottom, and to the occurrence of voids representing a large stope. Moreover, the tomogram shows that the hanging wall rock may be only a few meters thick, as indicated by the separation between the top of the low velocity (red) zone and the zone (green) representing low-velocity earth materials (possibly weak gravel or altered/weathered andesite). This condition is shown on the cross section to directly underlie existing SR 68. The expansion would have provided a new westbound set of lanes which would appear to the left of the roadway prism diagrammed in the cross section. That location would clearly have been underlain by even shallower mine workings with thinner hanging wall rock overlain by gravel. Note that the groundwater table was observed to be just below the 100 level.

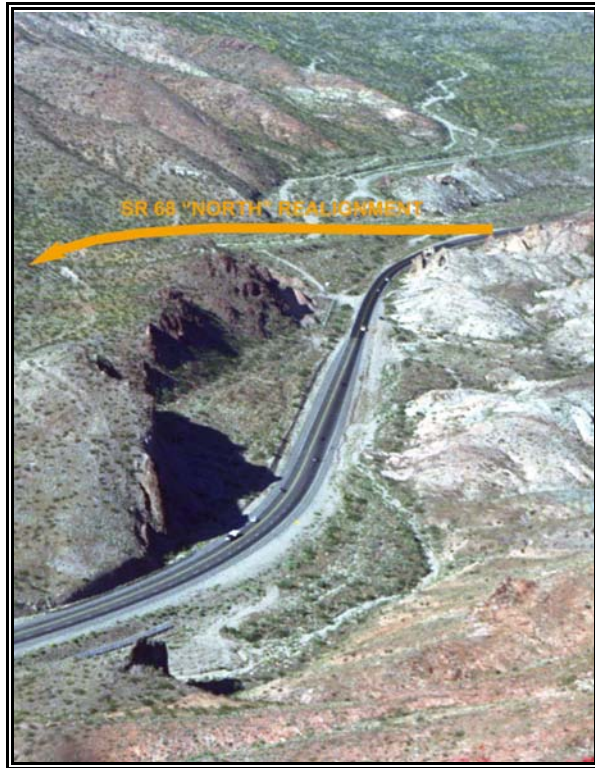
**Figure 26 – “North” realignment**

At other, more constrained sites, perhaps such engineering solutions could not be avoided. In this case the argument for relocation was compelling, even though it is often most convenient to expand the existing corridor rather than relocate it. In the end, the decision was taken to realign the highway to the north (Figure 26), through public land (and a few unpatented claims) that was known to be free of undermining. As it turned out, in part because the new construction could take place without interference from existing traffic, and in part because ROW acquisition did not have to be negotiated with the current Arabian Mine owner(s), the eventual cost of construction proved to be less than the projected cost of the improvements within the existing corridor.
